Warranty Replacement Information Error! Int. Error E031 (ABB Power One PVI-4.2-OUTD_AU)

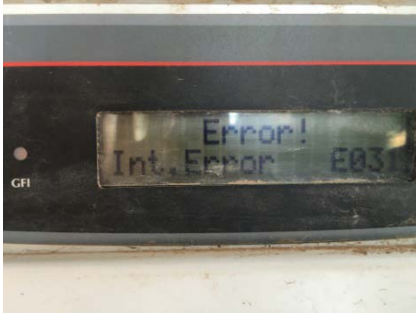
Recently, we have been attending a few inverter break downs from Power One, PVI-4.2-OUTD_AU with a Fault Error Code E031, this fault requires manufacture inverter replacement. Inverters that are less than 5 years old can receive a refurbished unit. The good news is that Power One (ABB group) are committed to ensure the inverter is replaced, additionally they offer a \$180.00 compensation for the cost of replacement.
